BASELINE RISK ASSESSMENT AND HAZARD IDENTIFICATION REPORT

**George Municipality: Tender ENG0042016:
Installation of Perimeter Concrete Palisade Fence**

Date of survey: 29 JANUARY 2016

The Hazard Identification and Risk Assessment of Occupational Health and Safety parameters on the premises of: **Pacaltsdorp Substation, ENG004/2016 Installation of Perimeter Concrete Palisade Fence**

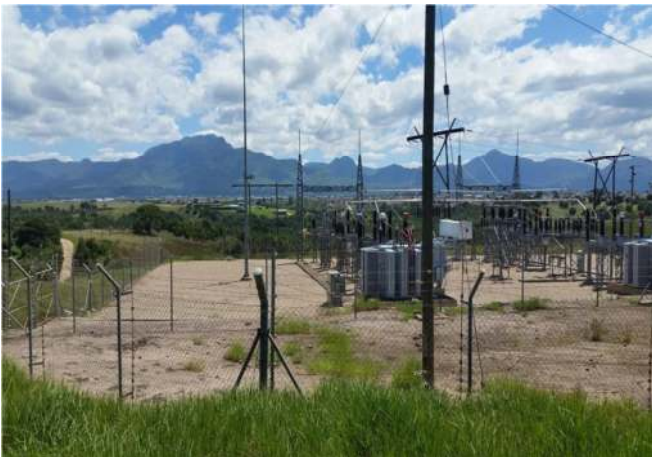
Fig 1

This project, the **Installation of Perimeter Concrete Palisade Fence** of the **Pacaltsdorp Substation, ENG004/2016 (Fig 1)** consists of the following elements:

- Fence would require installation of 450mm coiled razor wire on top of fence.
- Fence would require spacing for 2 gates as per drawings.
- Existing substation perimeter fence must remain intact.
- Total length makes provision for installation of palisade fence 1000mm away from current perimeter fence for safety and security reasons.
- All materials to be supplied by contractor.

- After hours security costs for materials and site to be included in tender.
- Fence installation and materials used need to be covered by 12 month warrantee.
- **CAUTION MUST EXERGISED DURING INSTALLATION TO PREVENT ANY DAMAGE TO ENERGISED 11 000 VOLT UNDERGROUND CABLES.**
- Duration of fence installation must be specified.
- Staff complement for installation must be specified.
- Material, accommodation and transport costs must be specified in bill of quantities.
- **POSTS, CROSS BARS AND PALES MUST ALL BE REINFORCED CONCRETE.**
- Specifications (dimensions) of posts cross bars and pales to be used must be specified.
- Strength of concrete used for manufacture of posts, cross bars and pales must be specified.
